HomeBuild Inspections LLC

Property Inspection Report

Client(s): **Sample Report 3/17/2018**
Property address: **1234 Snapfinger Road**
Ellenwood, GA 30294
Inspection date: **Saturday, March 17, 2018**

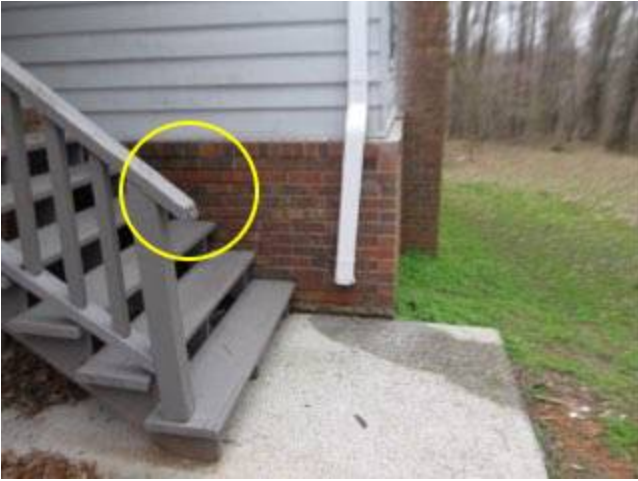
Photo 1-1

One or more handrails had no returns installed, where ends of handrails turn and connect to adjacent walls so objects or clothing will not catch on the open ends. This is a safety hazard. Recommend that a qualified person install returns per standard building practices.

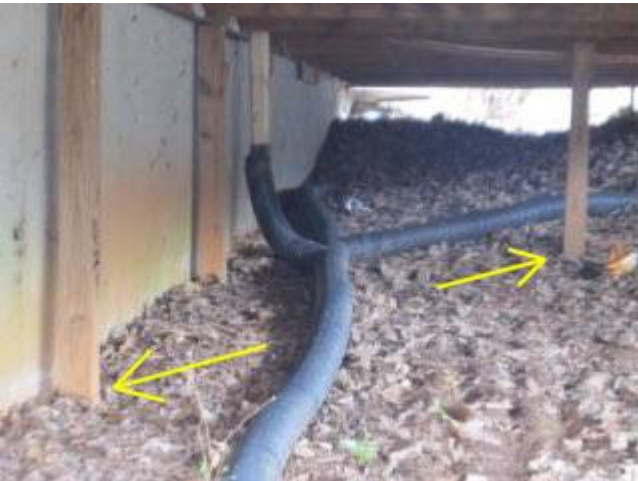
Photo 2-1

Soil was in contact with one or more wooden deck, porch or balcony support posts. This is a conducive condition for wood destroying organisms. Even if posts are made of treated wood, the cut ends below soil may not have been field treated. Recommend grading soil or repairing as necessary to prevent wood-soil contact.

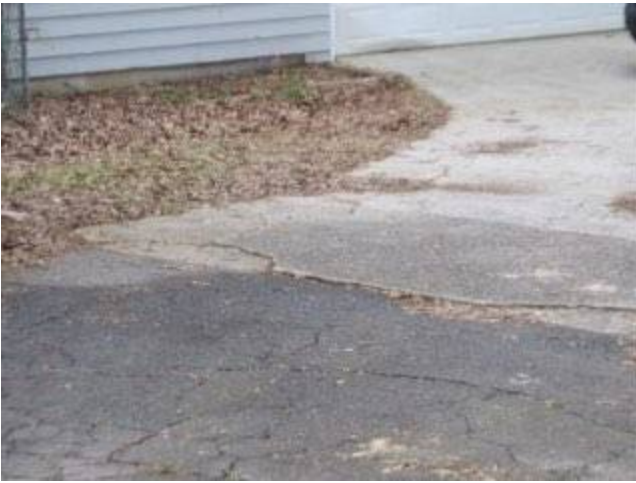
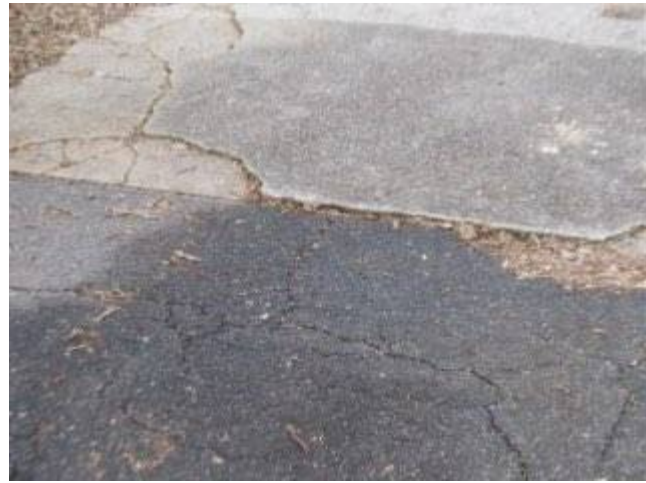
Minor deterioration (e.g. cracks, holes, settlement, heaving) was found in the driveway, but no trip hazards were found. The client may wish to have repairs made for cosmetic reasons.
Cost estimate: Observed multiple areas where driveway was cracked

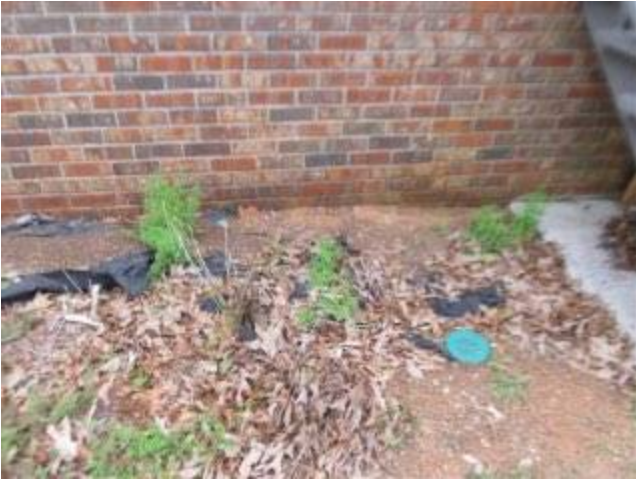
Photo 7-1

The masonry (brick or stone) veneer extended below the soil at one or more exterior walls. Masonry veneers should be installed so the bottom edge is at least a few inches above the soil so that any water accumulated inside the wall structure can drain from weep holes, and so termites don't enter the structure through mortar joints or cracks in the veneer. If soil, decorative bark, etc. has been back-filled against the veneer, it should be graded or removed as necessary to expose weep holes (if they're installed) and to maintain a few inches of clearance between the veneer and the soil below. Otherwise, the client should at least be aware of this potential for water and insect intrusion, and monitor these walls inside and out for any signs of accumulated moisture in the future. If damage occurs, recommend that a qualified contractor repair as necessary. For more information, visit:

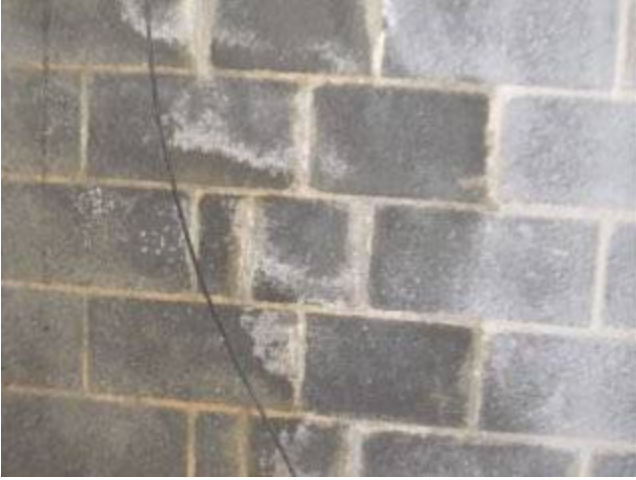
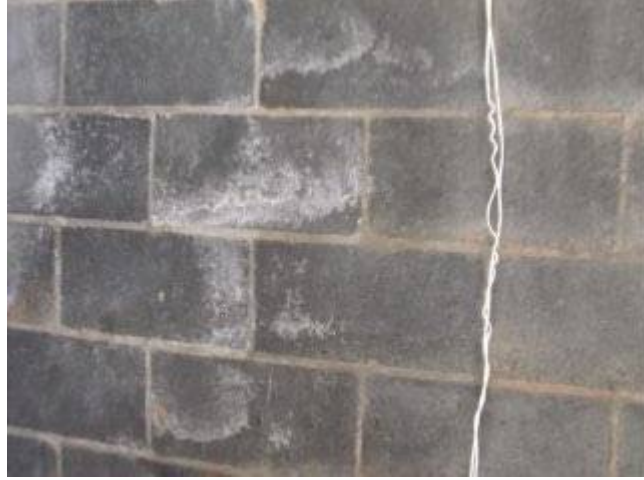
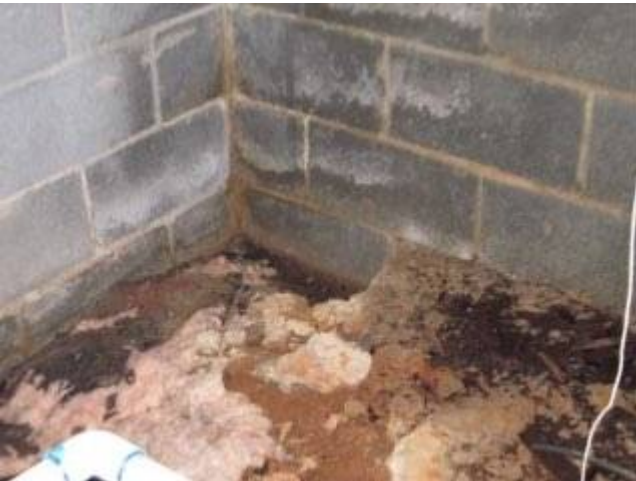
Evidence of prior water intrusion or accumulation was found in one or more sections of the crawl space. For example, sediment stains on the vapor barrier or foundation, and/or efflorescence on the foundation. Accumulated water is a conducive condition for wood-destroying organisms and should not be present in the crawl space. Recommend that the client review any disclosure statements available and ask the property owner about past accumulation of water in the crawl space. The crawl space should be monitored in the future for accumulated water, especially after heavy and/or prolonged periods of rain. If water is found to accumulate, then recommend that a qualified contractor who specializes in drainage issues evaluate and repair as necessary. Typical repairs for preventing water from accumulating in crawl spaces include:

- Repairing, installing or improving rain run-off systems (gutters, downspouts and extensions or drain lines)
- Improving perimeter grading

- Repairing, installing or improving underground footing and/or curtain drains

Ideally, water should not enter crawl spaces, but if water must be controlled after it enters the crawl space, then typical repairs include installing trenches, gravity drains and/or sump pump(s) in the crawl space.

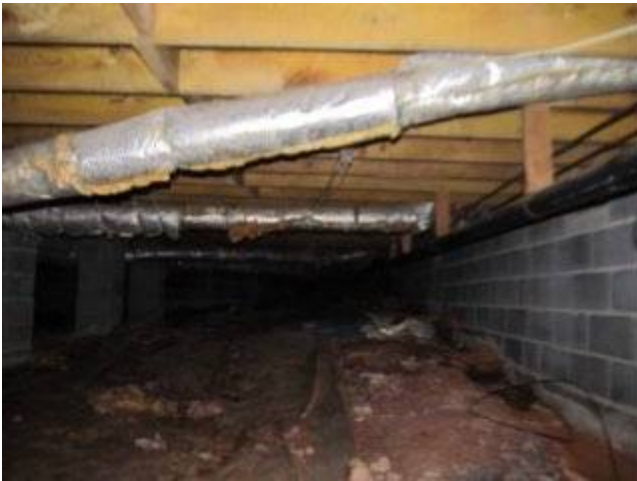
Photo 10-1

No vapor barrier was installed in the crawl space. This is a conducive condition for wood-destroying organisms due to the likelihood of water evaporating from the soil below up into the structure. A 6 mil black plastic sheet should be placed over all exposed soil with seams overlapped to 24 inches, and not in contact with any wood structural components. The sheeting should be held in place with bricks or stones, not wood. Recommend that a qualified contractor install a vapor barrier per standard building practices.

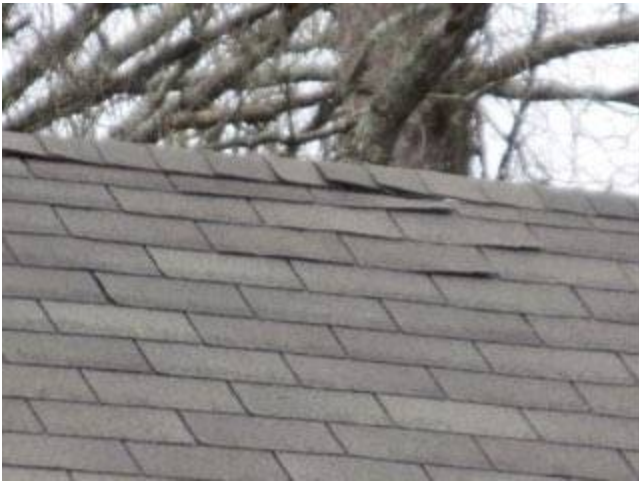
Photo 12-1

- 12) 🛠️ Some composition shingles were loose. Leaks can occur as a result. This is a conducive condition for wood-destroying organisms. Recommend that a qualified contractor repair as necessary. For example, by replacing shingles.

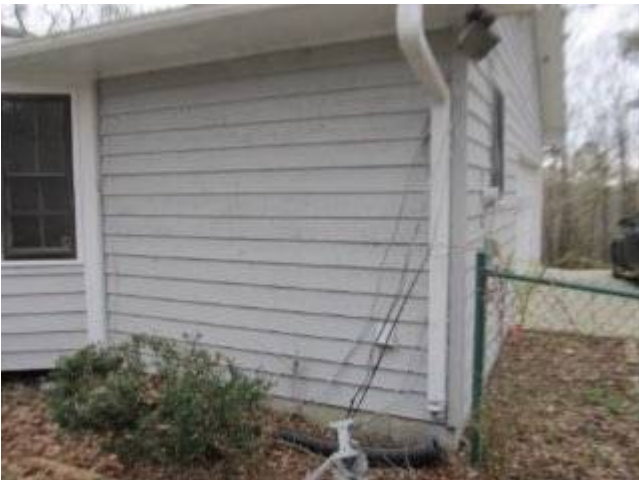
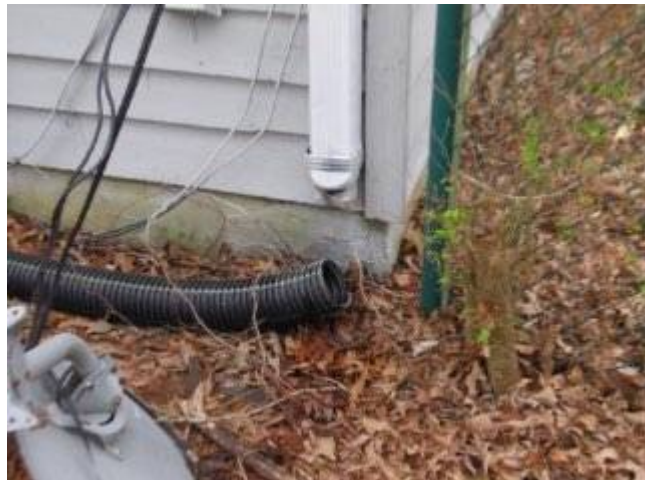
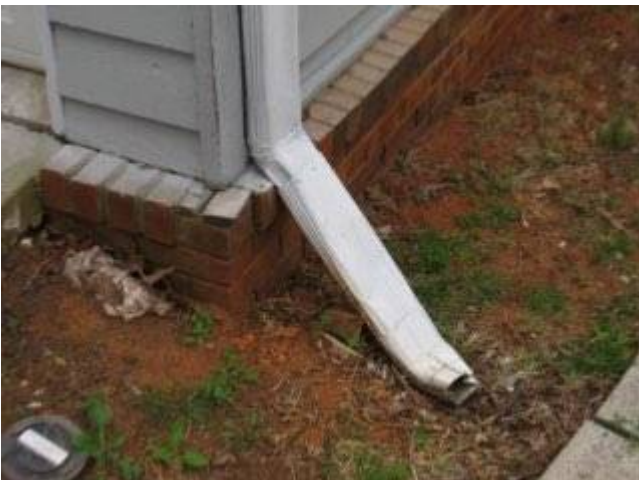
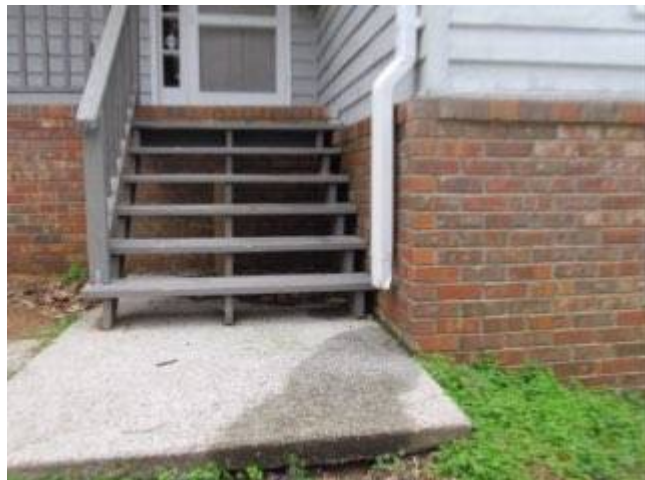
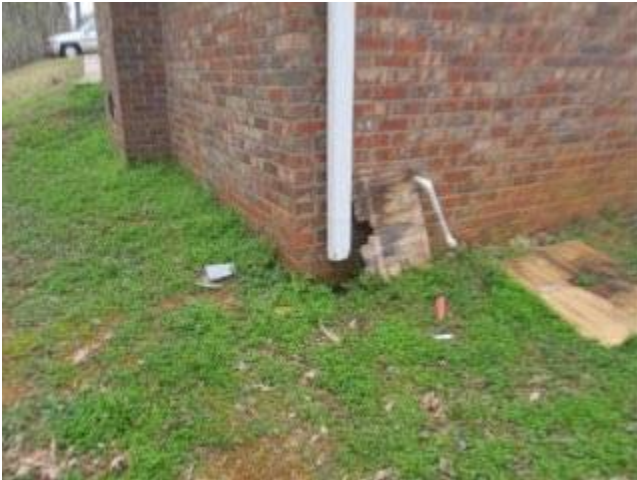
Extensions such as splash blocks or drain pipes for one or more downspouts were missing, substandard and/or damaged. Water can accumulate around the building foundation or inside crawl spaces or basements as a result. Recommend that a qualified person install, replace or repair extensions as necessary so rainwater drains away from the structure.

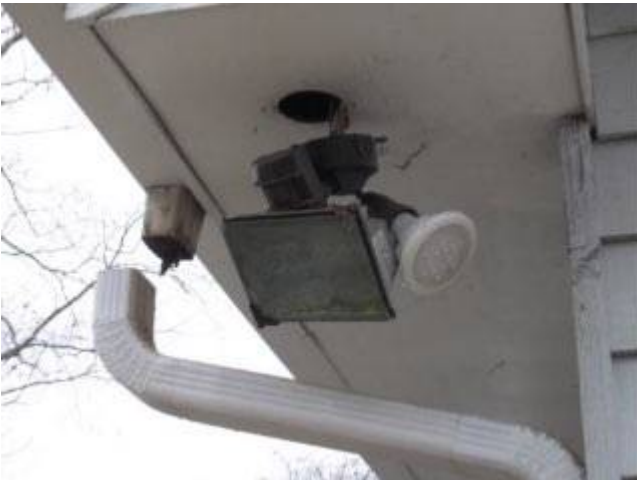
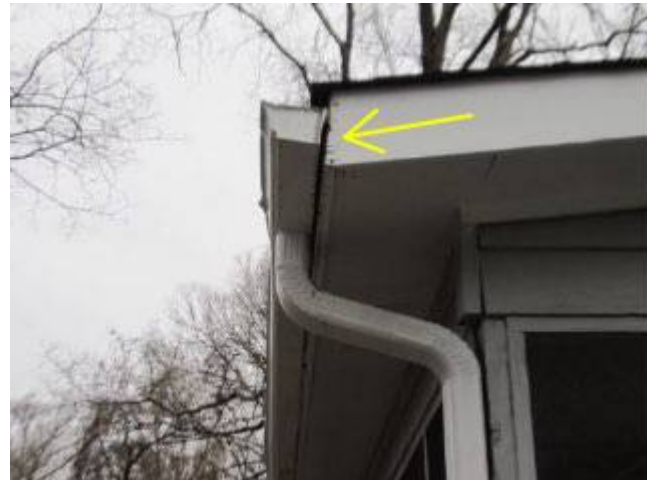
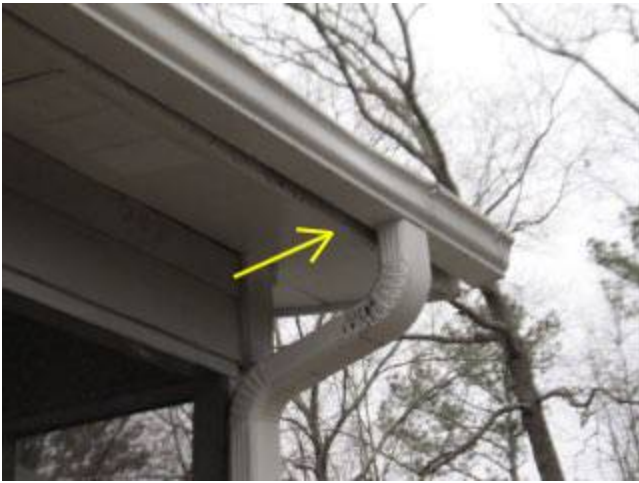
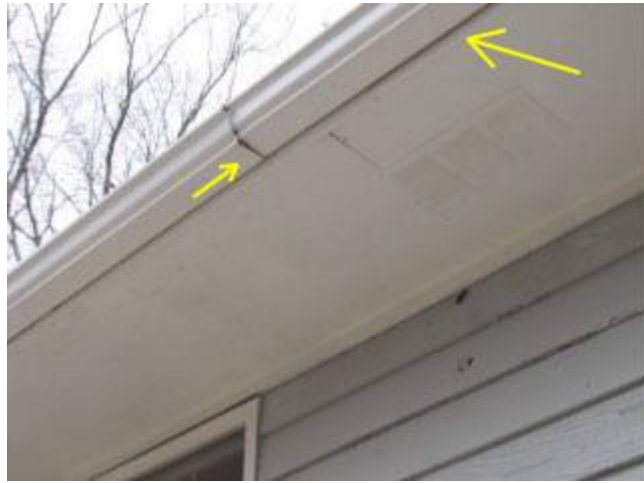
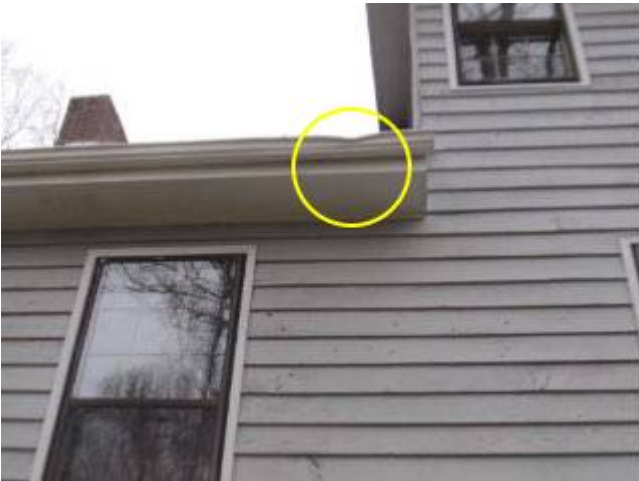
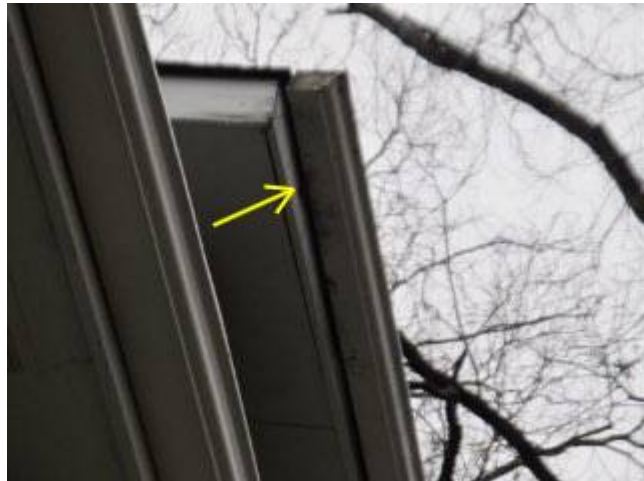
One or more gutters and/or downspouts were loose. Rainwater can come in contact with the building exterior or accumulate around the building foundation as a result. This is a conducive condition for wood-destroying organisms. Recommend that a qualified person repair as necessary.

Observed several areas where gutters were pulling away from fascia board. Also noticed areas where downspouts were not securely fastened to gutters.

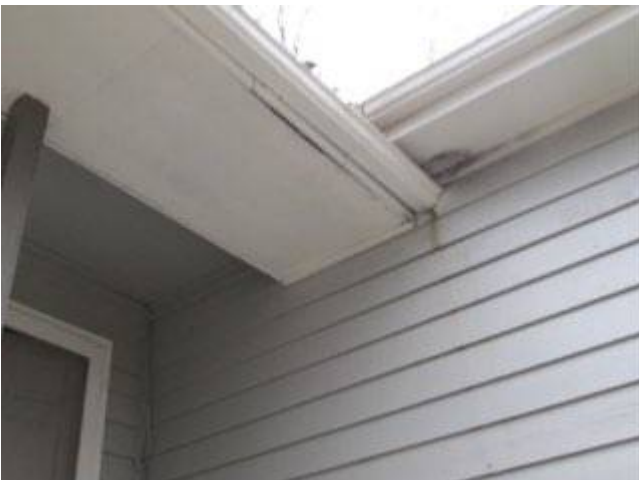
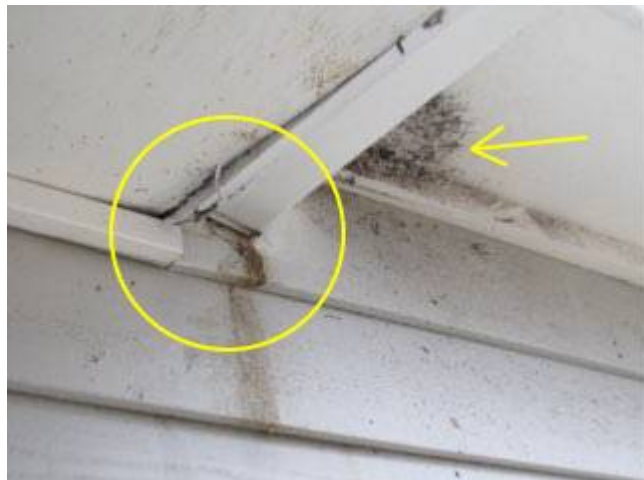
Significant amounts of debris have accumulated in one or more gutters or downspouts. Gutters can overflow and cause water to come in contact with the building exterior, or water can accumulate around the foundation. This is a conducive condition for wood-destroying organisms. Recommend cleaning gutters and downspouts now and as necessary in the future.

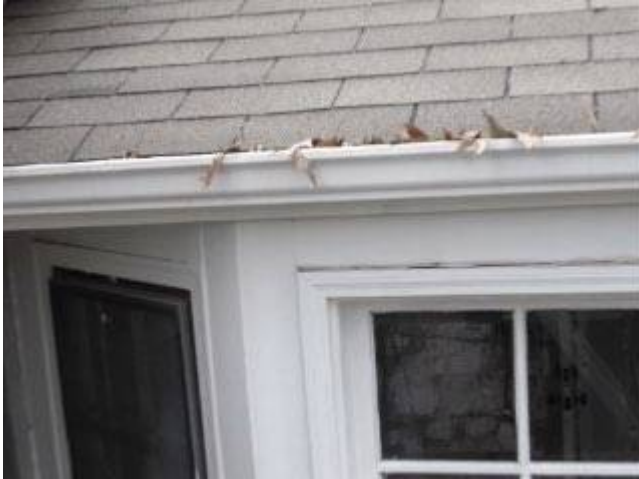
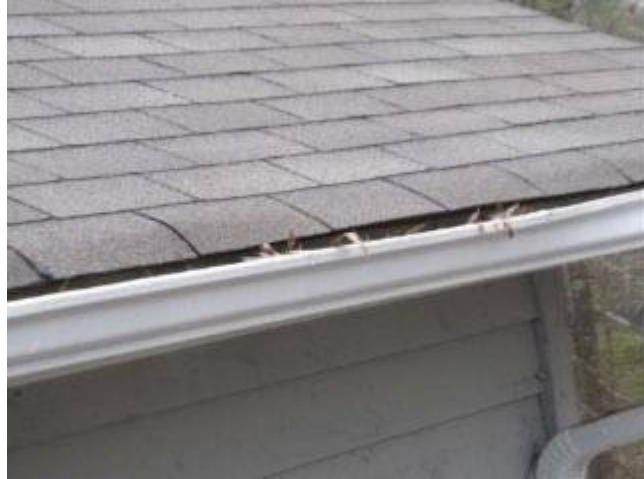
Significant amounts of debris such as leaves, needles, seeds, etc. have accumulated on the roof surface. Water may not flow easily off the roof, and can enter gaps in the roof surface. Leaks can occur as a result. This is a conducive condition for wood-destroying organisms. Recommend cleaning debris from the roof surface now and as necessary in the future.

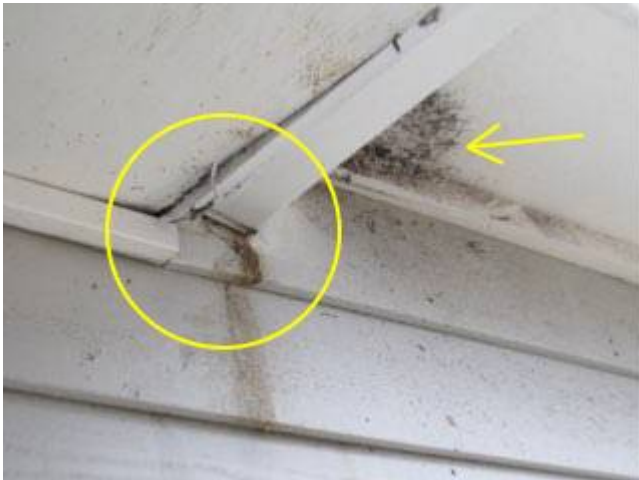
Photo 17-1

Stains were found on one or more gutters that indicate past leaks have occurred. However, the inspector was unable to verify that the gutters do or don't leak because of lack of recent rainfall. Monitor the gutters in the future while it's raining to determine if gutters leak. If they do, then recommend that a qualified person repair as necessary to prevent water from coming in contact with the building or accumulating around the building foundation.

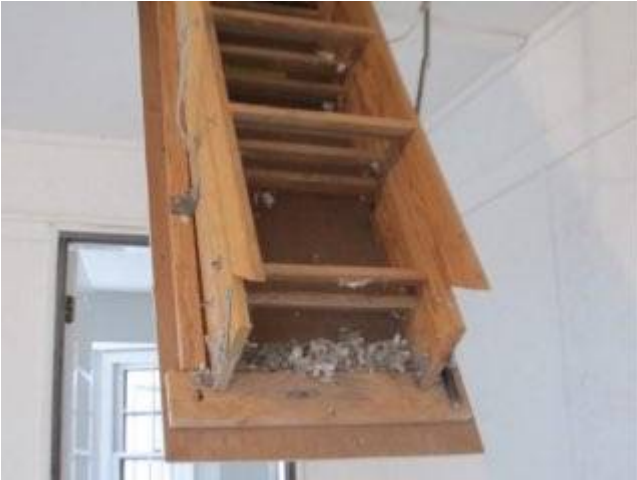
Photo 18-1

One or more attic access hatches or doors were not insulated, or had substandard insulation. Recommend installing insulation as necessary and per current standards at hatches or doors for better energy efficiency. For more information, visit:

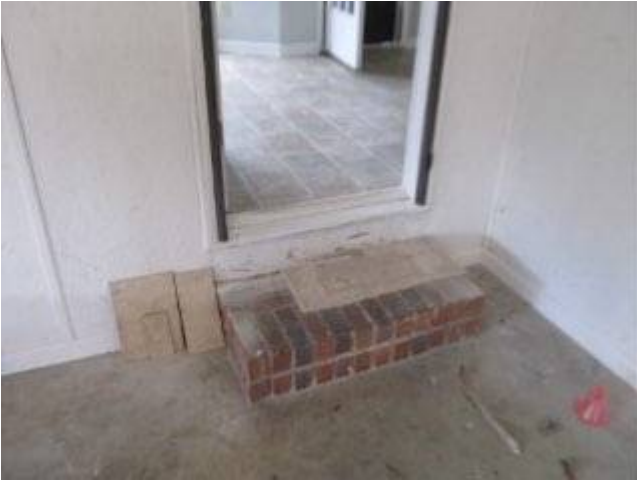
Photo 20-1

The step(s) installed below the door between the garage and the house were substandard. This is a fall or trip hazard. A qualified person should repair as necessary.

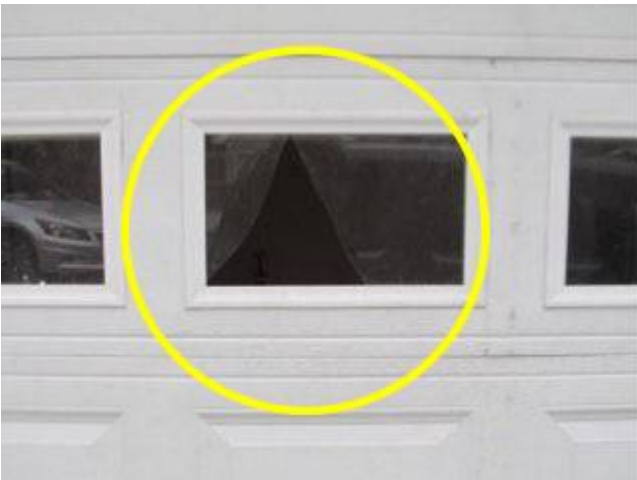
Photo 21-1

One or more garage vehicle doors were damaged or deteriorated. Recommend that a qualified contractor repair or replace door(s) as necessary.

Observed broken window on garage door.

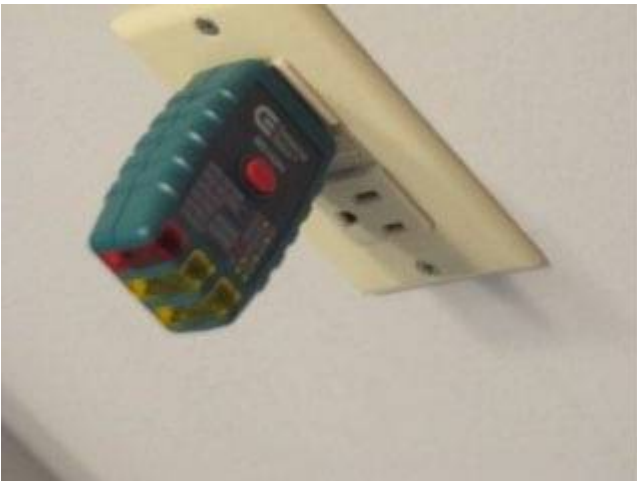
Photo 22-1

One or more ground fault circuit interrupter (GFCI) devices protecting receptacles at the bathroom(s) . This is a potential shock hazard. Recommend that a qualified electrician evaluate and repair as necessary.

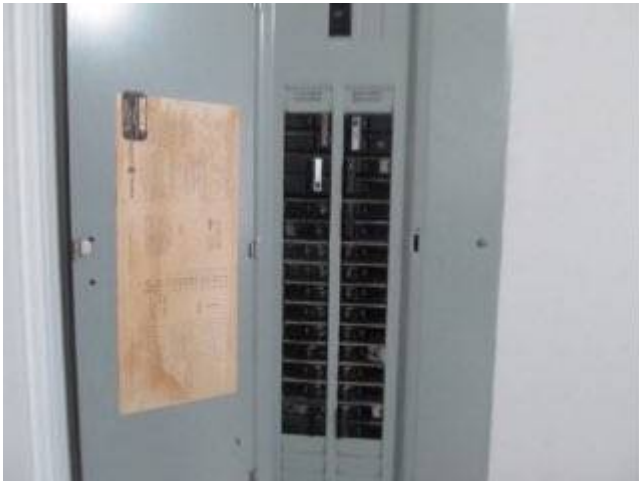
Photo 24-1

Panel(s) #A had inadequate working space. This is a safety hazard when opening or working in panels. Electric panels should have the following clearances:

Service panel is located behind entrance door in laundry room.

Recommend that a qualified contractor repair or make modifications per standard building practices. If panels must be opened for repairs, then a qualified electrician should perform repairs.

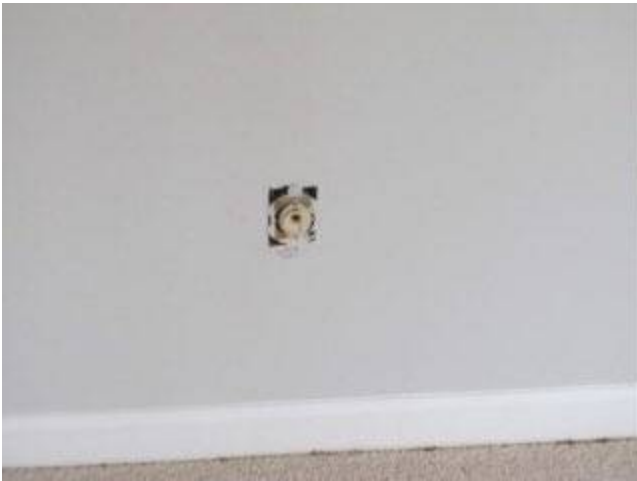
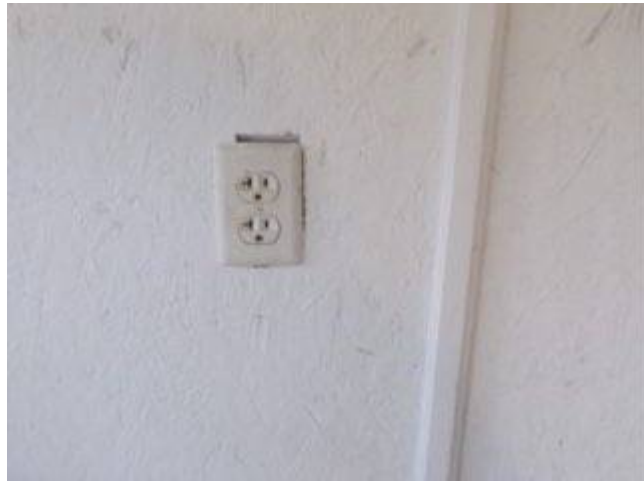
One or more cover plates for switches, receptacles or junction boxes were missing or broken. These plates are intended to contain fire and prevent electric shock from occurring due to exposed wires. Recommend that a qualified person install cover plates where necessary.

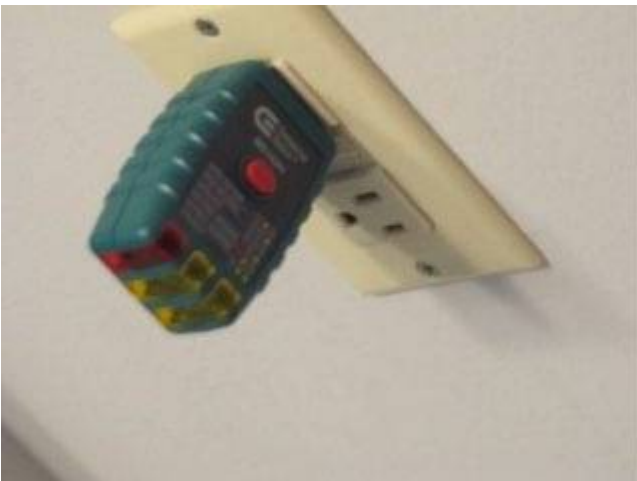
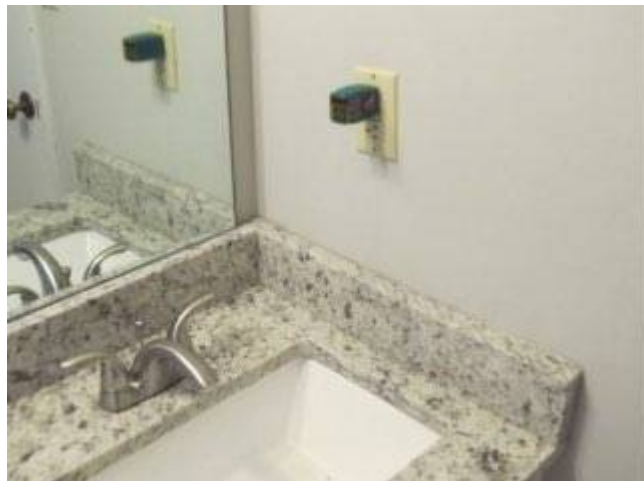
26) 🔧🔍 One or more electric receptacles appeared to have no power. Recommend asking the property owner about this. Switches may need to be operated or GFCI/AFCI protection may need to be reset to make some receptacles energized. If necessary, recommend that a qualified electrician evaluate and repair.

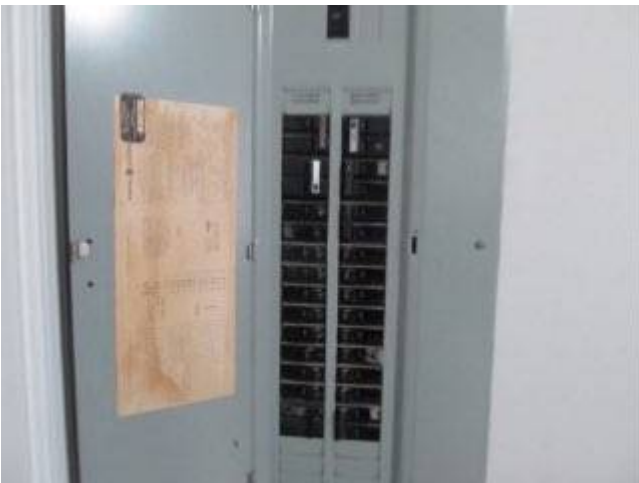
Photo 28-1

The legend for circuit breakers or fuses in panel(s) #A was missing, incomplete, illegible or confusing. This is a potential shock or fire hazard in the event of an emergency when power needs to be turned off. Recommend correcting the legend so it's accurate, complete and legible. Evaluation by a qualified electrician may be necessary.

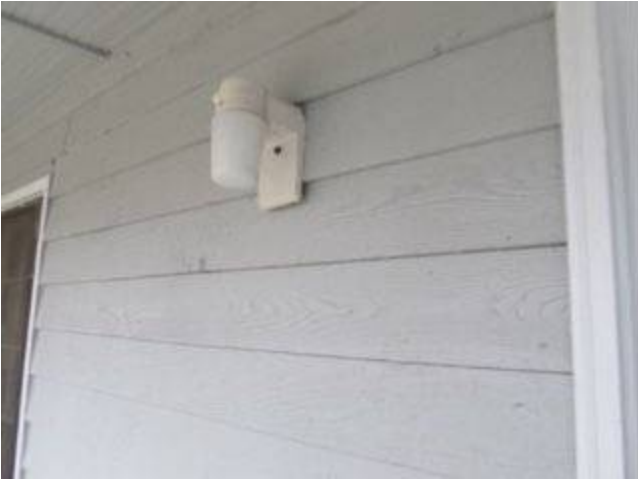
Photo 29-1

One or more light fixtures were inoperable (didn't turn on when nearby switches were operated). Recommend further evaluation by replacing bulbs and/or consulting with the property owner. If replacing bulbs doesn't work and/or no other switch(es) can be found, then recommend that a qualified electrician evaluate and repair or replace light fixtures as necessary.

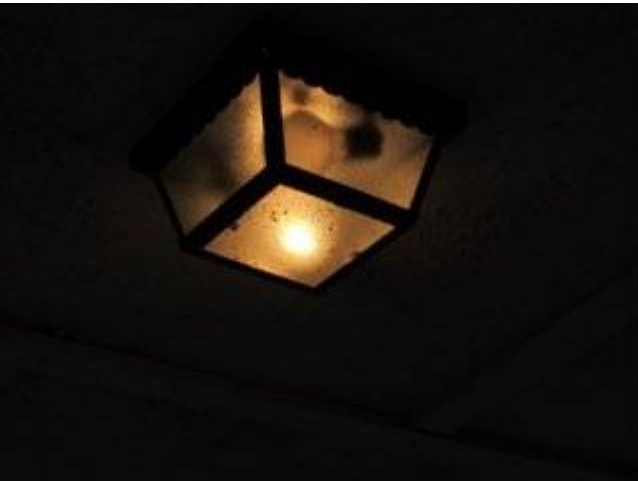
Photo 30-1

Bulbs in one or more light fixtures were missing or broken. These light fixtures couldn't be fully evaluated. If replacement bulbs are inoperable, then recommend that a qualified electrician evaluate and repair or replace light fixtures as necessary.

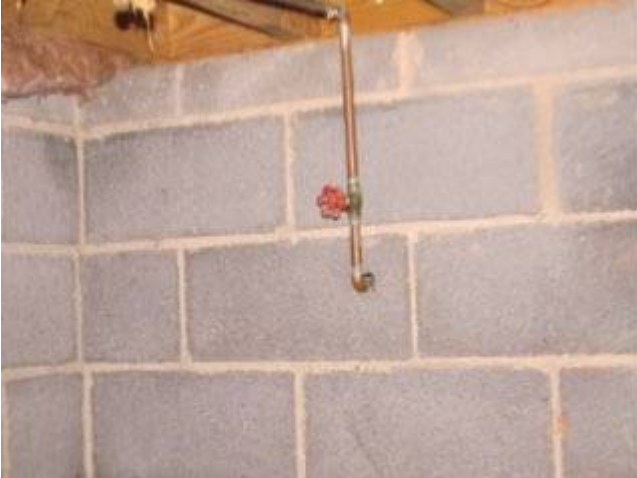
Photo 31-1

31) **i** What appeared to be the main water shut-off valve was located in the crawl space. This is an inconvenient location at best, and may prevent the water from being turned off in a timely manner in the event of a plumbing emergency. Consider having a qualified plumber relocate the shut-off valve to a more convenient location, such as in a closet or a cabinet under a sink.

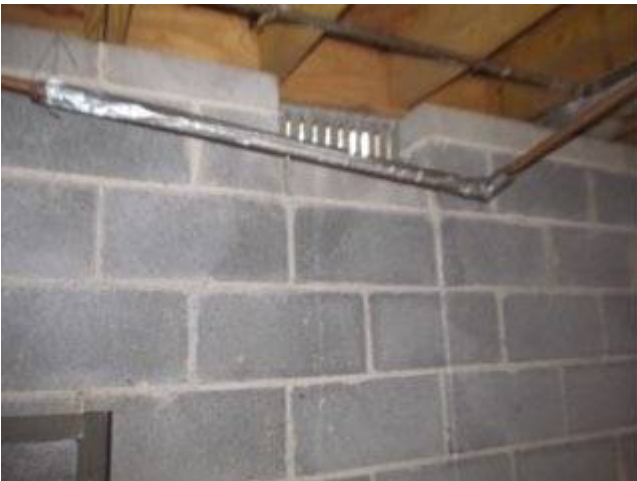
Photo 32-1

32) Observed duct tape wrapped around sections of the copper water lines located in crawl space. Recommend a qualified contractor to evaluate and determine cause for duct tape used and repair if needed.

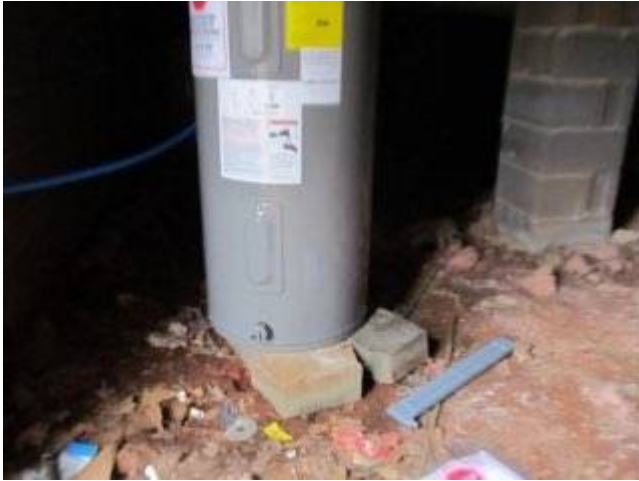
Photo 33-1

The water heater was installed in an unheated space on a concrete floor and was not resting on an insulated pad. The bottom of the casing is likely to rust, and energy efficiency may be reduced. Recommend installing an insulated pad under the water heater.

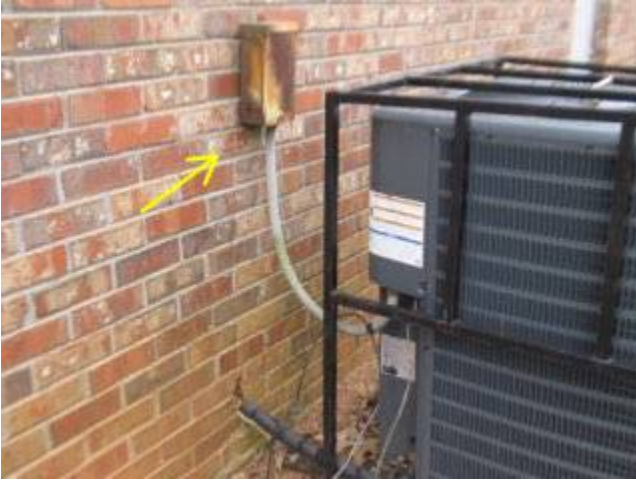
Photo 34-1

34) Main cut off switch was located directly behind the ac unit less than 18". Not allowing for adequate workspace when ac unit is serviced.

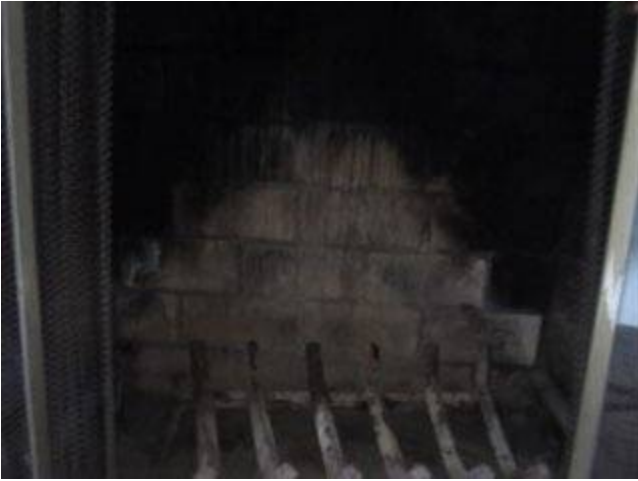
Photo 35-1

A significant amount of creosote or burning by-products (ash, soot, etc.) was visible in one or more chimneys. This is a potential fire hazard and a sign that chimney system maintenance has been deferred. The client should be aware that the type and quality of wood burned, and the moisture content of the wood, will affect the rate at which burning by-products accumulate in the chimney. When solid fuel-burning devices are used regularly, they should be cleaned annually at a minimum. A qualified contractor should evaluate, clean, and repair if necessary.

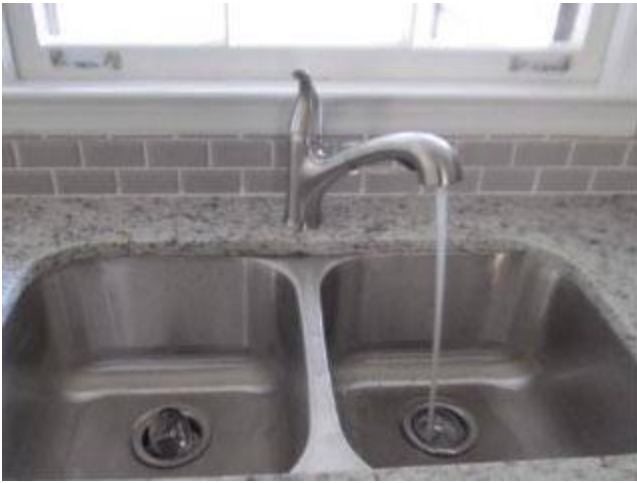
Photo 37-1

One or more sink faucet handles were loose. Recommend that a qualified person repair or replace as necessary.

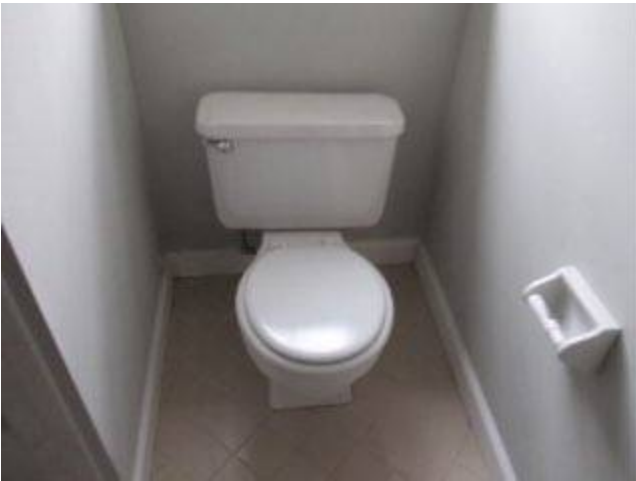
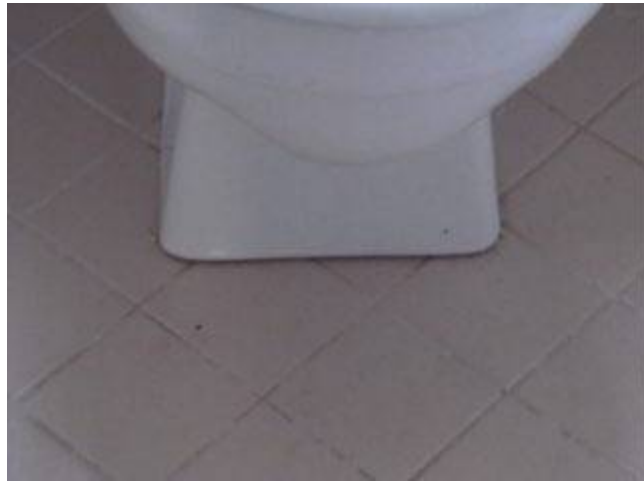
The toilet at location(s) #A and B was loose where it attached to the floor. Leaks can occur. Flooring, the sub-floor or areas below may get damaged. Sewer gases can enter living spaces. Recommend that a qualified contractor remove the toilet(s) for further evaluation and repair if necessary. A new wax ring should be installed and toilet(s) should be securely anchored to the floor to prevent movement and leaking.

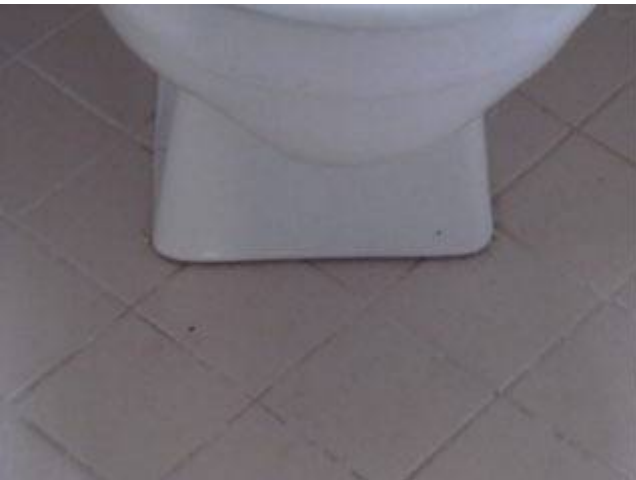
Photo 40-1

Caulk around the base of the toilet at location(s) # was missing, substandard and/or deteriorated. Modern standards require caulk to be installed around the entire toilet base where it meets the floor for sanitary reasons. Without it, soiled water can soak into flooring and sub-floor materials if the toilet overflows. Condensation from the toilet can also soak into the flooring. Recommend that a qualified person caulk around toilet bases per standard building practices.

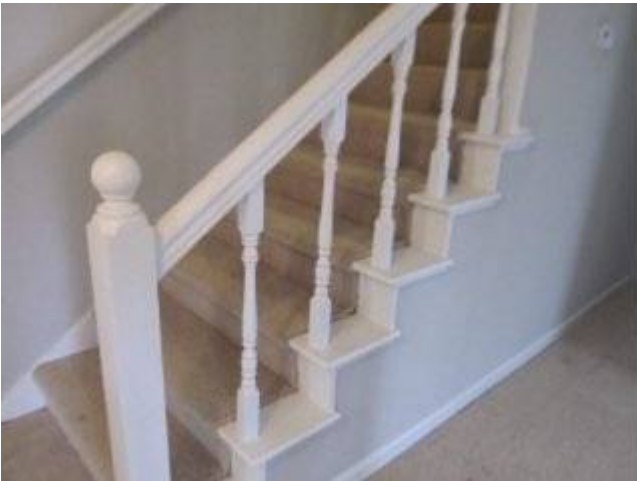
Photo 41-1

Guardrails at one or more locations with drop-offs higher than 30 inches had gaps that were too large. This poses a safety hazard for children (e.g. falling, getting stuck in railing). Guardrails should not have gaps or voids that allow passage of a sphere equal to or greater than 4 inches in diameter, or 6 inches in diameter at triangular spaces between stair edges and guardrails. At a minimum, the client should be aware of this hazard. Recommend that a qualified contractor repair or replace guardrails per standard building practices.

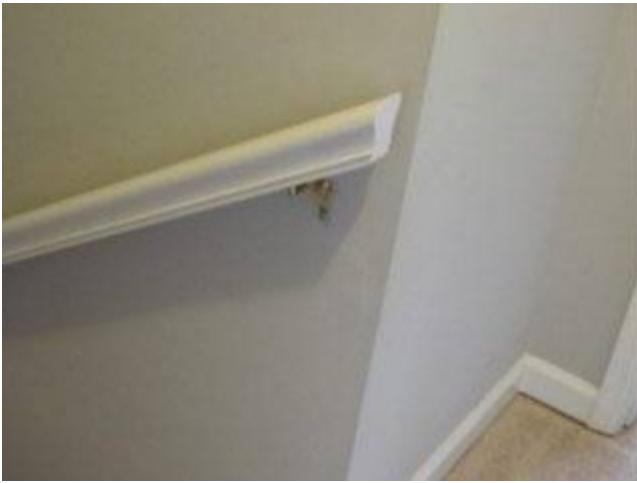
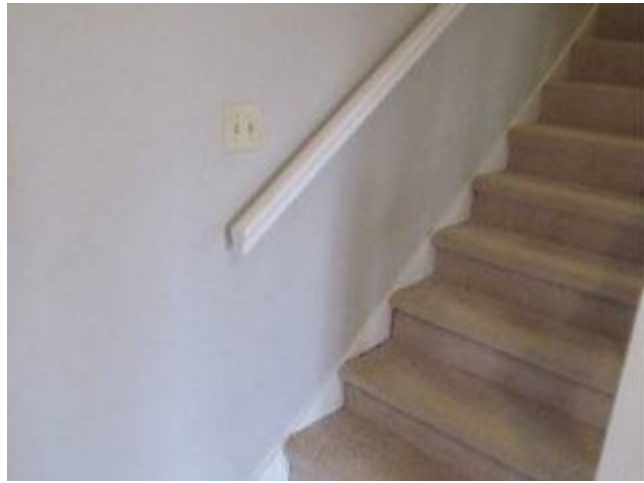
One or more handrails had no returns installed, where ends of handrails turn and connect to adjacent walls so objects or clothing will not catch on the open ends. This is a safety hazard. Recommend that a qualified person install returns per standard building practices.

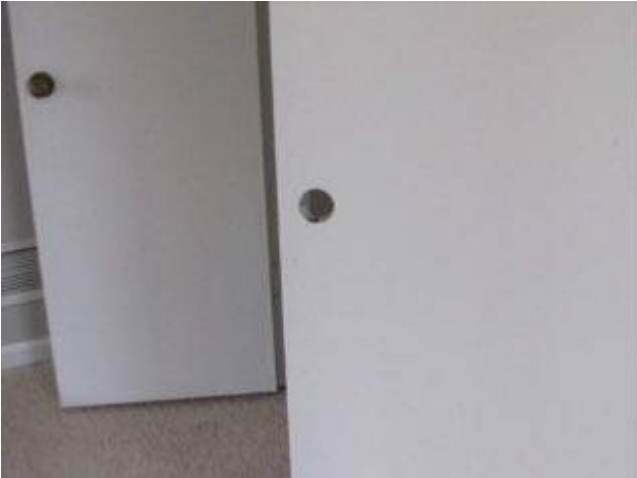
**Photo 43-1**

Some interior door hardware (doorknobs) were missing. Recommend that a qualified person repair or replace as necessary.

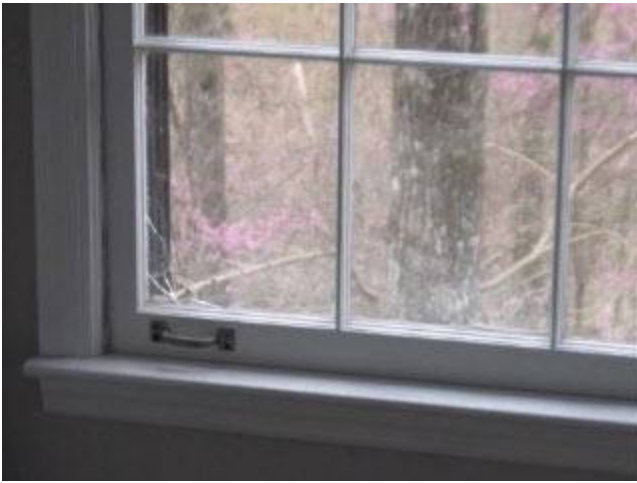
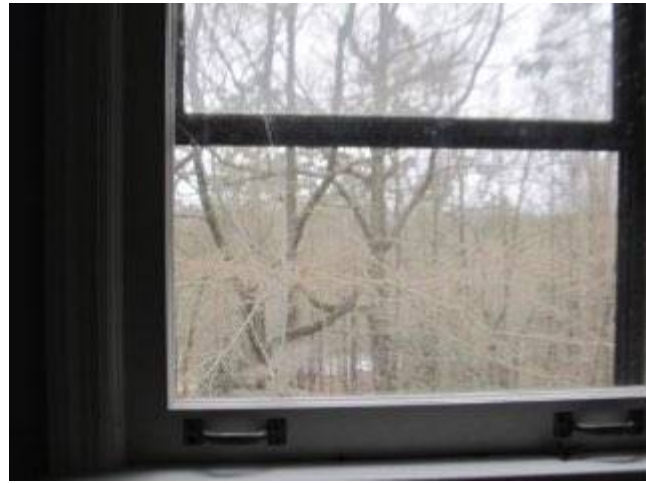
Glass in one or more windows was cracked, broken and/or missing. Recommend that a qualified contractor replace glass where necessary.
